# **METAL / NONMETAL**

## **Serious Injury Accident**

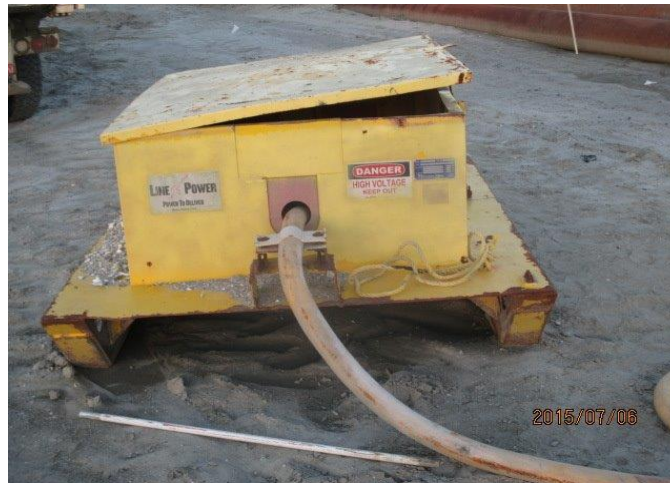
Surface Phosphate Mine – A miner was injured while preparing to add a 1000 ft. cable to a junction box on a 7200 volt power circuit. The victim opened the junction box and placed the static grounding clamp assembly across the corner of the open junction box. The grounding clamp assembly fell into the junction box making contact with the energized conductors. An arc flash occurred severely injuring the miner.

- Become familiar with the electrical circuits prior to performing any electrical work.
- Always make sure electrical circuits are de-energized before performing any electrical work.
- Perform your own lock-out and tag-out procedure and NEVER rely on others to do this for you.
- Develop, communicate, and execute a written plan before performing electrical troubleshooting and repair to ensure that safety is maximized for all miners involved in the task.
- Use proper Personal Protective Equipment (PPE) for all electrical work.
